Report No.	01		
Page	1	Of	4
Date	Monday	5-7-2012	
CSI Job No.:	212125

Daily Coating Inspection Report (Concrete)

Project: Tiger Creek Adhesion Testing	Inspector: Tim Grady/ NACE # 4688
Client: Pacific Gas and Electric	Contractor: None Onsite
Client Contact: Ron Basques P.E.	Foreman: None Onsite

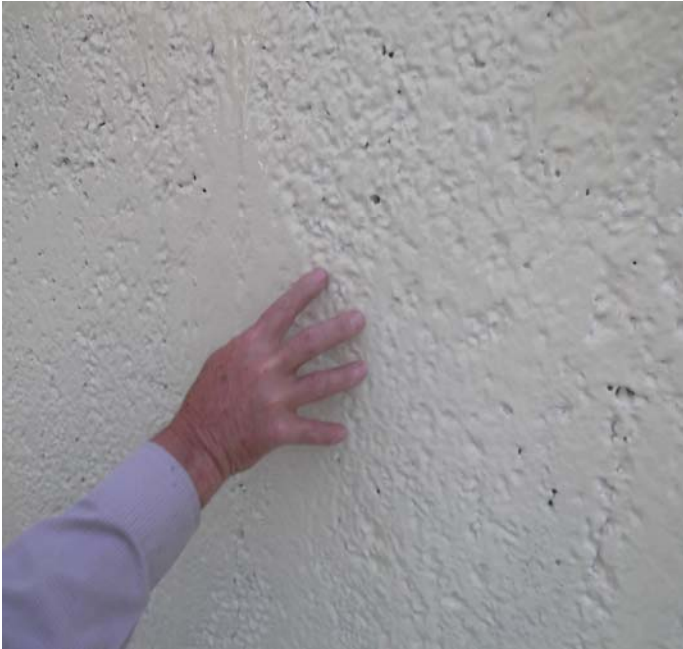
Comments: The applied coating on the walls and floor is CT-T 301-03 Warren Epoxy Manufacture, applied by Certified Coatings. Mr. Basques stated that the required mil thickness was 60-80 mils but that was not achieved due to not having the correct material on hand during the application evolution. There is evidence of bug holes that were not filled and some outgassing from the application during inclining temperatures. The test location is approximately 100 feet long by 10 foot high walls. The test locations have new coating applied over existing Coal Tar material.

Figure#1: Example of Bug Holes Not Filled with Coating.

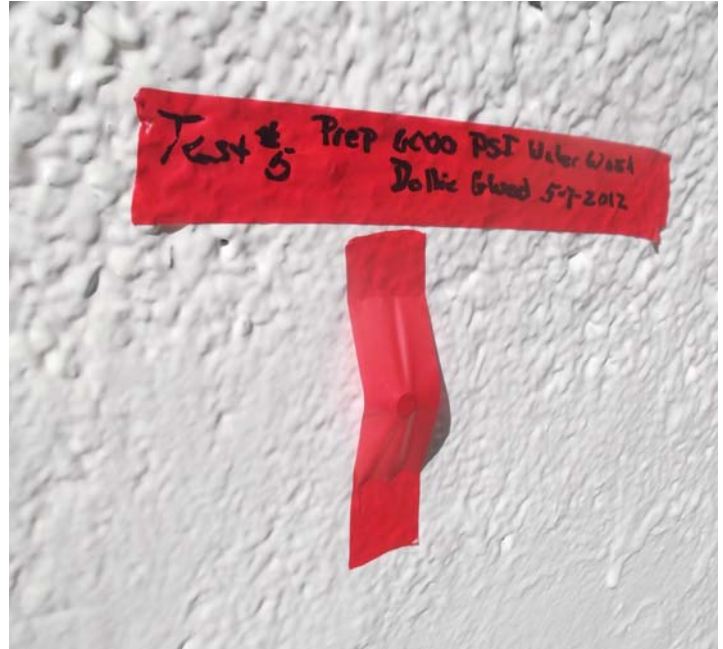
Figure#2: Example of Adhesion Test Dolly Set and Labeled.

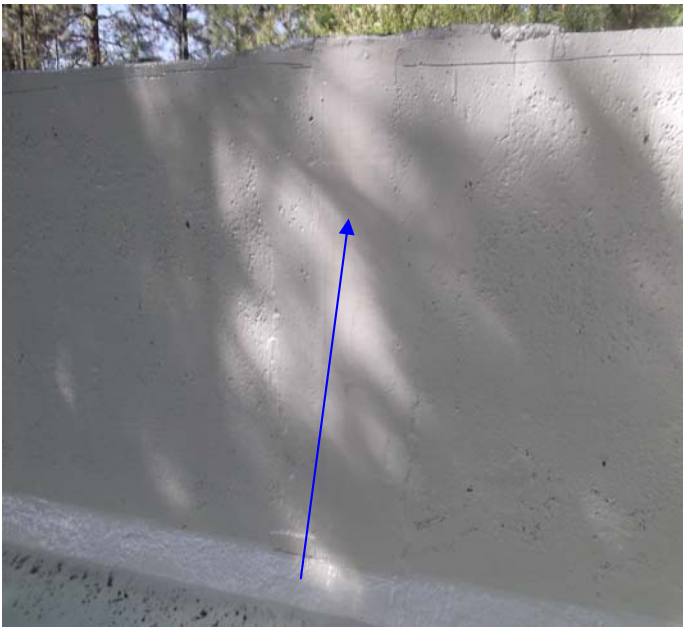
Figure#3: Expansion Joint Treatment Inside Trough.

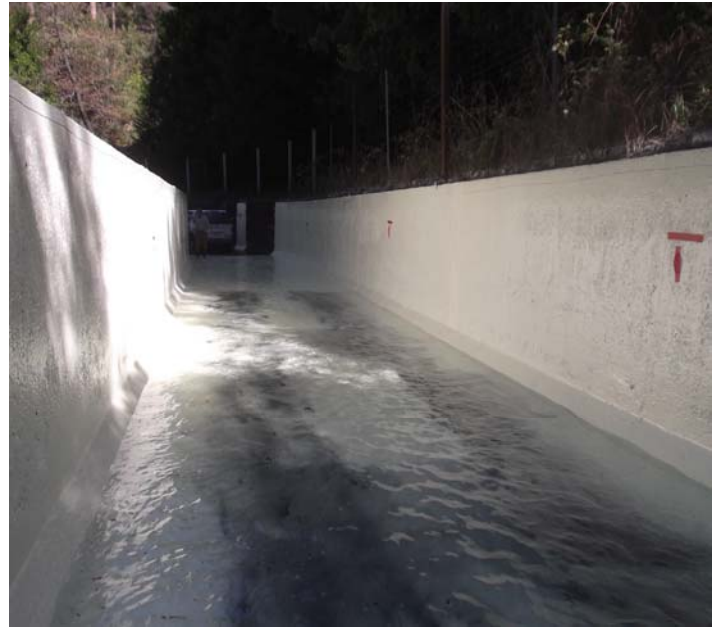
Figure#4: Overview of Adhesion Test Location Station 337+36.

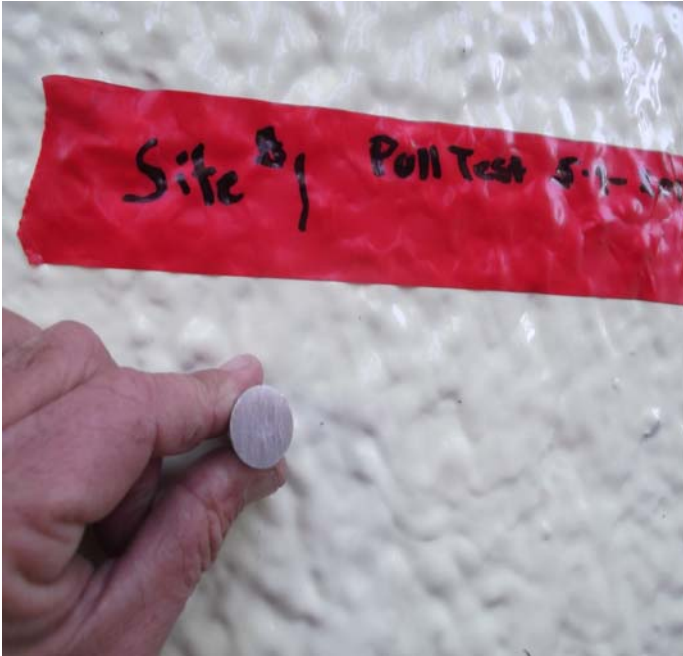
Comments CSI Services Inspector (Tim Grady) arrived at the Tiger Creek PG&E Power Plant office as per our client's request for the Adhesion Test on the walls of the canal at Station 337+36 locations were the dummies were glued on 5-8-2012. CSI Services was taken back up the mountain to the work location and the Adhesion Pull Test was conducted. All of the adhesion dummies were pulled off with glue failure at the dummies due to inspector not preparing the adhesion dummy correctly prior to the gluing process. When CSI Services inspector discovered that there was a problem discussion with CSI Services office the decision was made to re glue the adhesion dummies on the coated walls after correctly preparing the dummies.

Figure#1: Example of Adhesion Dolly with Incorrect Prep.

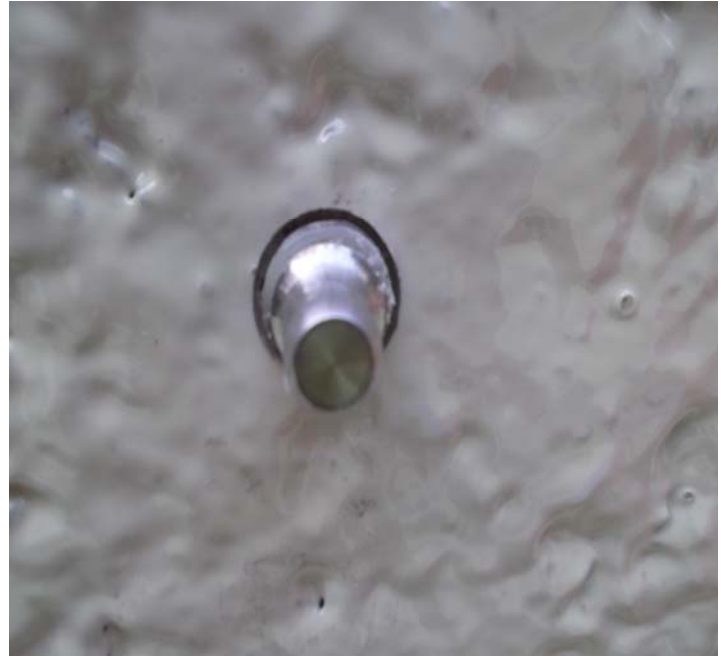
Figure#2: Example of Scored Adhesion Dolly on Coating.

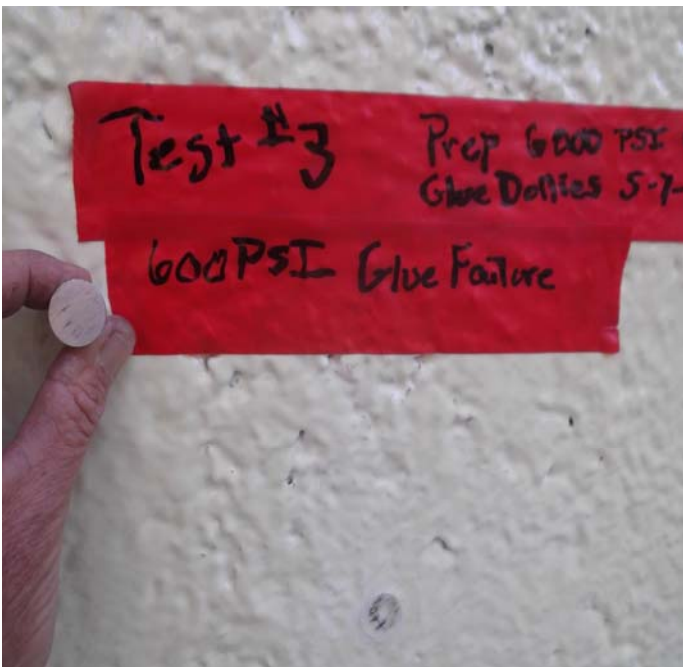
Figure#3: Another Example of Dolly Glue Failure.

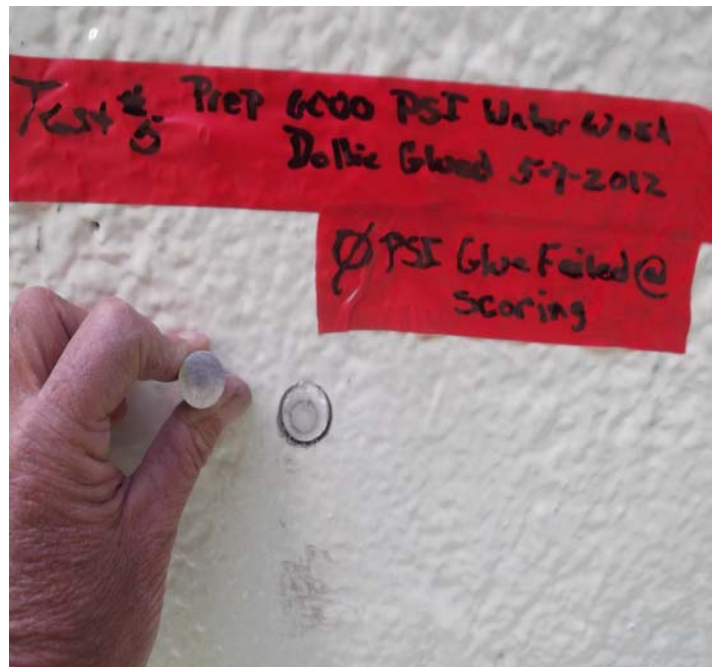
Figure#4: Scored Dolly Failure at Dolly to Glue.

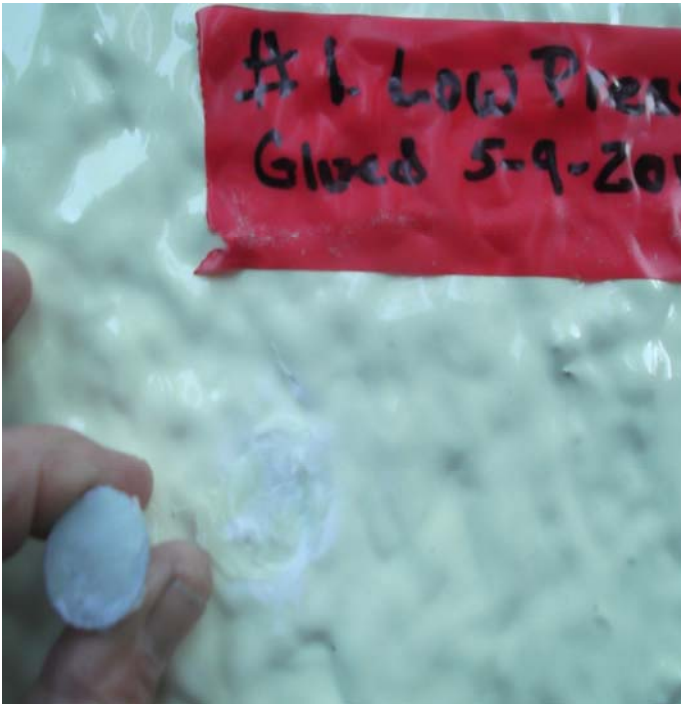
- Site #1: Prep Water Wash (Low Pressure) and Saw Cuts, No Score on Dolly 600 PSI, Adhesive Failure.
- Site #1 A: Prep Water Wash (Low Pressure) and Saw Cuts, No Score on Dolly 450 PSI Adhesive Failure.
- Site #2: Prep 6000 PSI Water Wash, No Score on Dolly 850 PSI Adhesive Failure.
- Site #3: Prep 6000 PSI Water Wash, No Score on Dolly 400 PSI Adhesive Failure.
- Site #4: Prep 6000 PSI Water Wash, Adhesion Dolly Scored 600 PSI Adhesive Failure.
- Site #5: Prep 6000 PSI Water Wash, Adhesion Dolly Scored 750 PSI Coating Failed to Coal Tar.
- Site #6: Prep 6000 PSI Water Wash, Adhesion Dolly Scored 750 PSI Coating Failed to Coal Tar.
- Site #7: Prep 6000 PSI Water Wash, No Score on Dolly 800 PSI Coating Failure to Coal Tar.
- Site #8: Prep None 475 PSI No Score on Dolly Adhesive Failure.

Figure#1: Site#1, Adhesive Failure at 450 PSI.

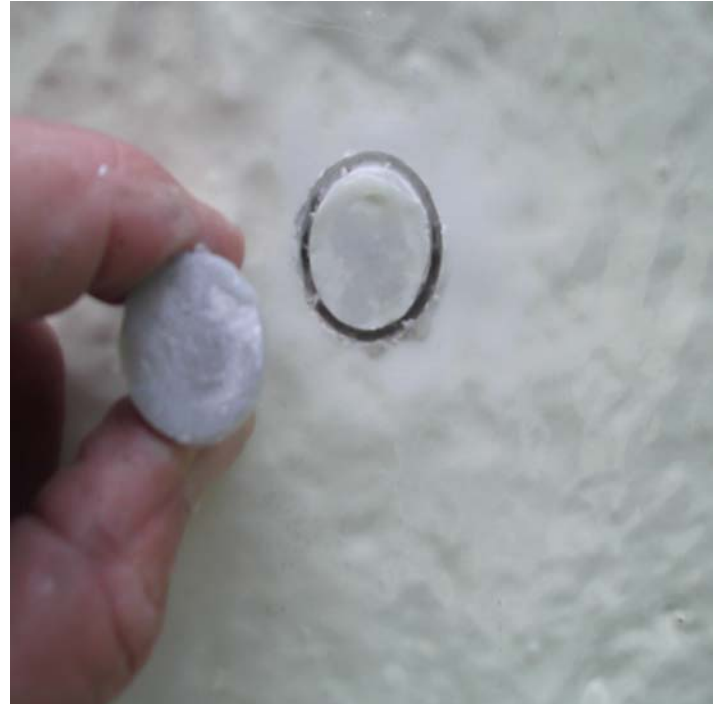
Figure#2: Example of Scored Dolly Site#5 750 PSI Adhesive.

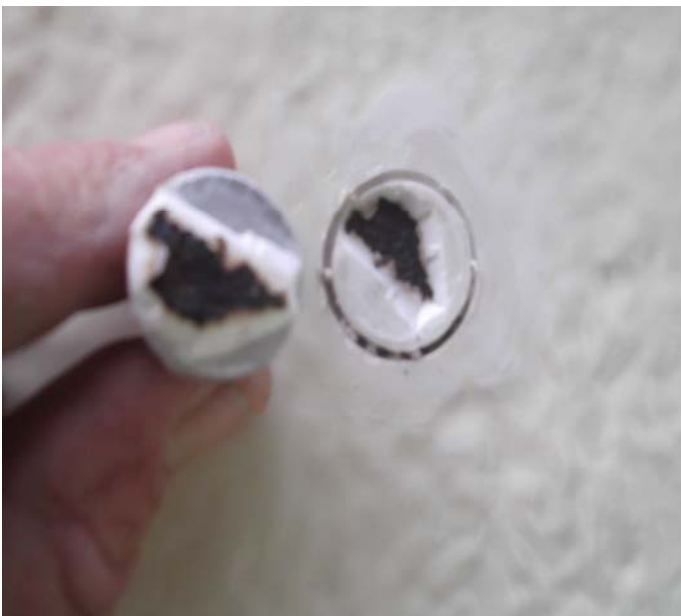
Figure#3: Site #6 Scored Dolly, 750 PSI Coating Failure.

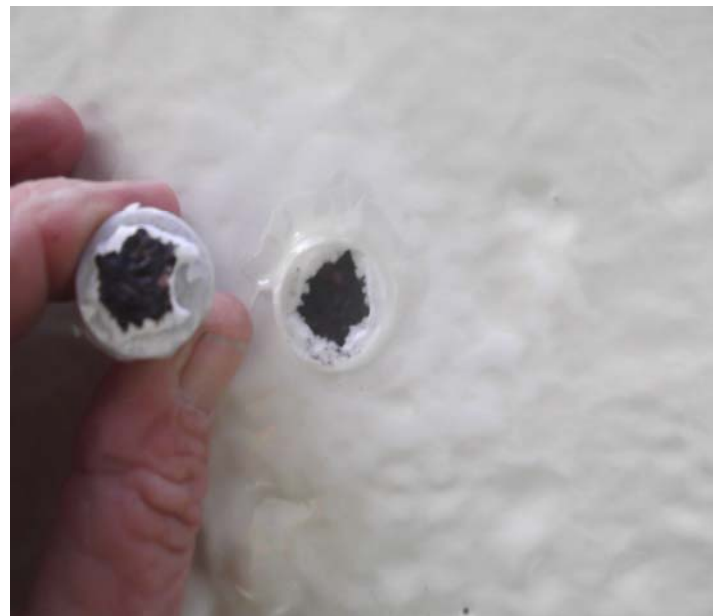
Figure#4: Site #7, No Score 800 PSI Coating Failure.
