# The Haysboro Water Feedermain - Product Test

S-301 Epoxy Spray System  
Warren Environmental Inc. and A & W Maintenance Inc.

THE CITY OF  
**CALGARY**  
WATER RESOURCES

February 11, 2009

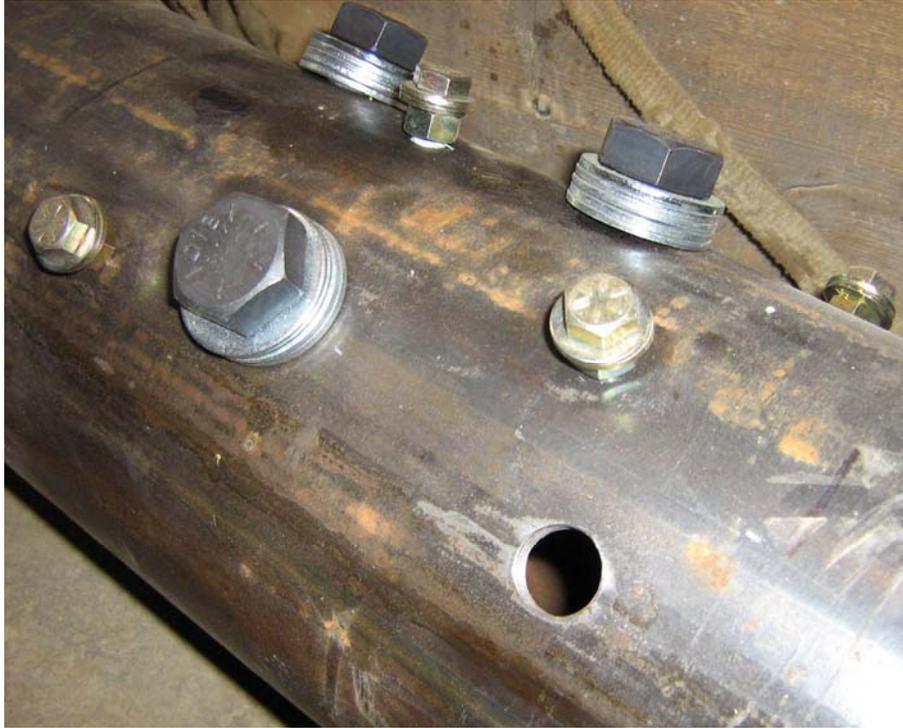
**Figure 3 Photo of second group of holes on the bare metal pipe.**

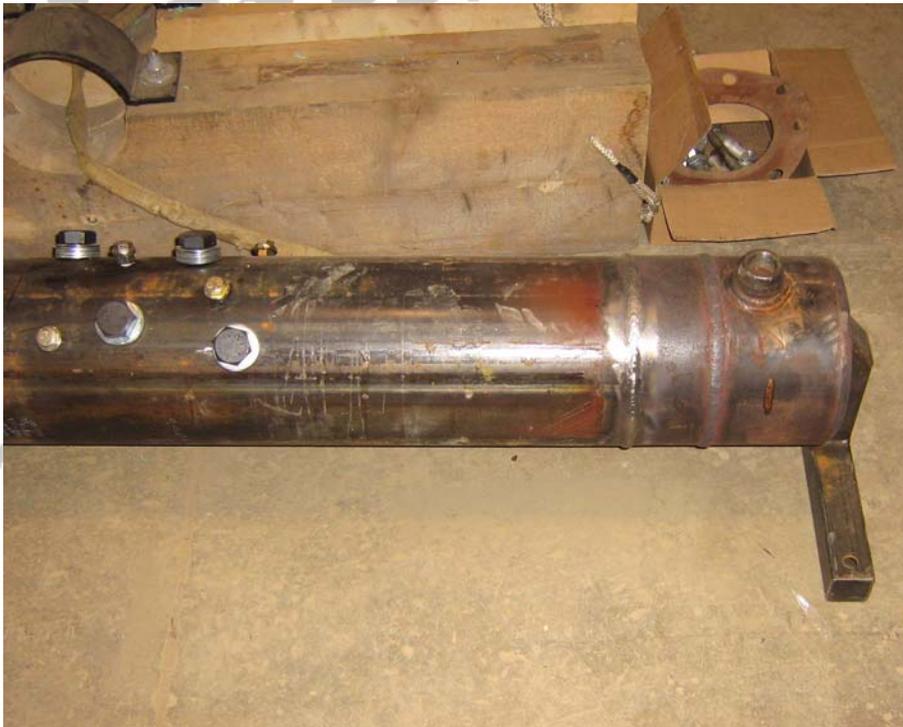
**Figure 4 Photo of the bare metal pipe, the second group of holes, and the end with the welded cap.**

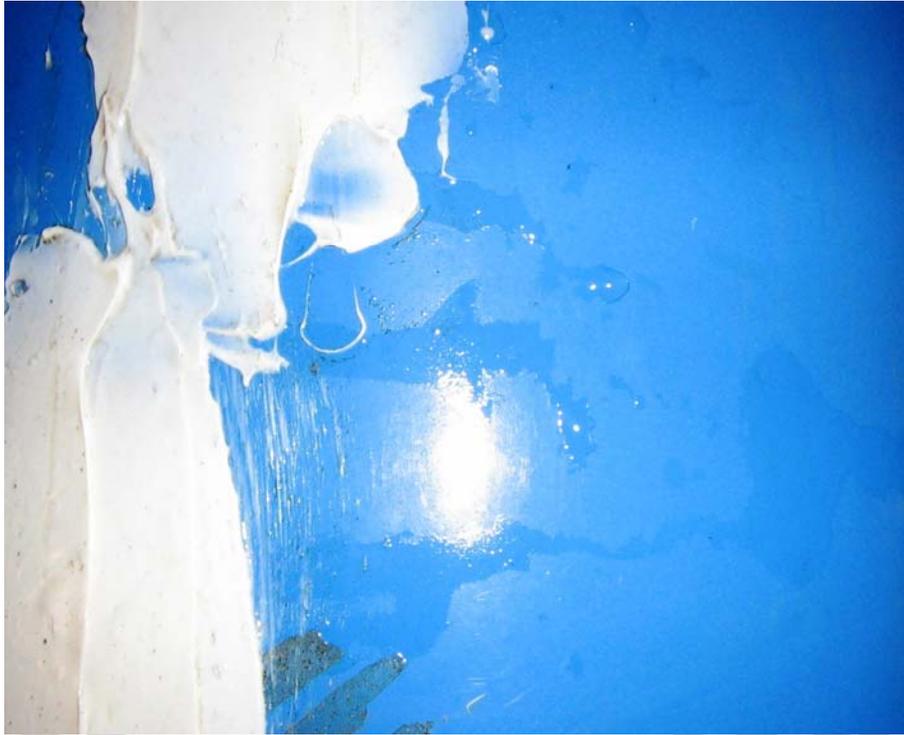
The pressure was initially brought to 100 psi (690 kPa) then increased in 50 psi (345 kPa) increments. After each increase, the pipe was left for 5 minutes during which time the exterior was checked for leaks. Since there were no leaks, the pressure was brought to 600 psi (4137 kPa) and left over night. The pressure did not remain at 600 psi (4137 kPa) due to slight weeping at the fittings. The fittings were tightened and the pressure brought back up to 500 psi (3447 kPa), using the same method as the day before. It was left overnight at 500 psi (3447 kPa). The next morning a small slow pinhole leak had appeared (Figure 11). The pipe was re-pressurized but the leakage remained relatively small with no crack propagation.

Figure 11 Slow leak from the coated metal pipe.

pinhole as a temporary repair (Figure 13). The pipe was then retested. The pressure was brought up to 250 psi (1724 kPa). Since no leaks appeared, the pressure was increased to 500 psi (3447 kPa) in 50 psi (345 kPa) increments. The 500 psi (3447 kPa) held overnight with no new leaks.

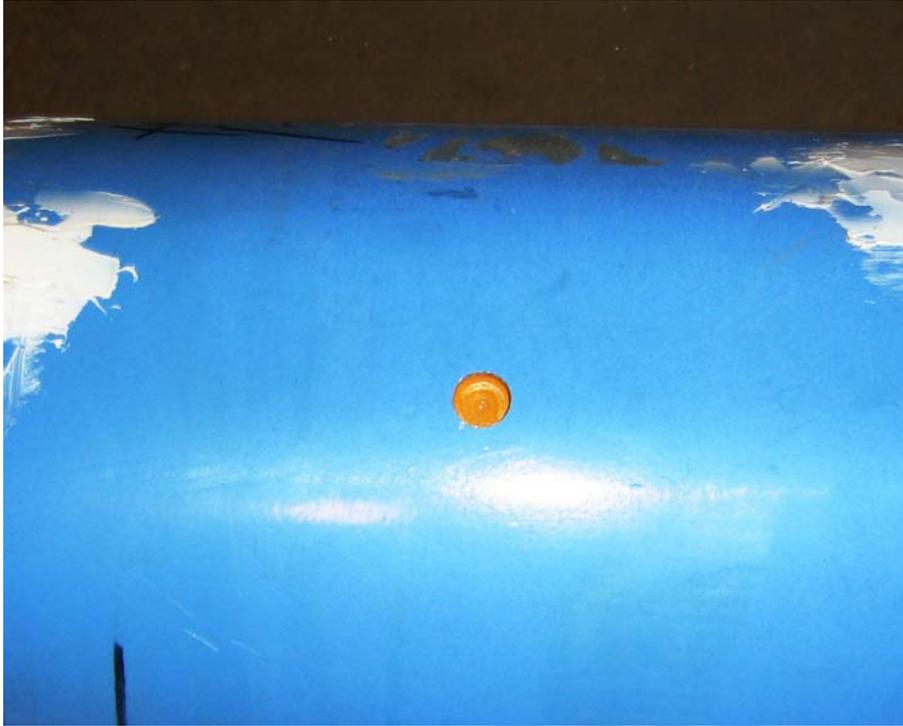
Further testing was performed on the pipe by welding two outlets onto the pipe surface to test the effect of welding on the epoxy. One outlet used a gas welding procedure and one used an arc welding procedure. A new hole was also drilled through the metal to the exterior surface of the epoxy (Figure 12). As well, a saddle was placed over the leaking

**Figure 12 Hole drilled through the steel to the epoxy.**

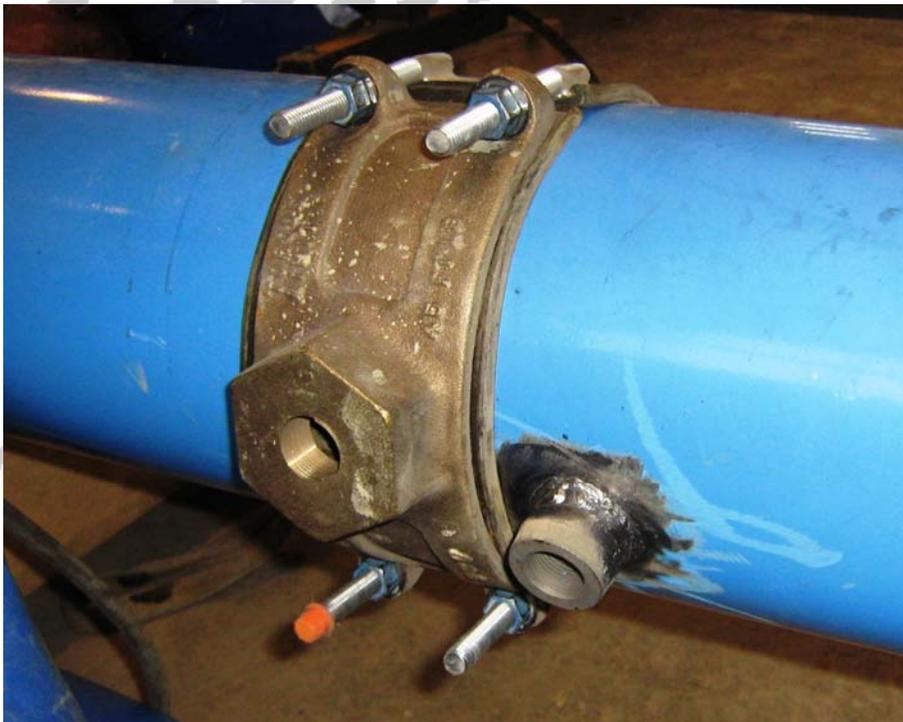
**Figure 13 Coated pipe with the outlet welded on and the leak fitted with a saddle.**

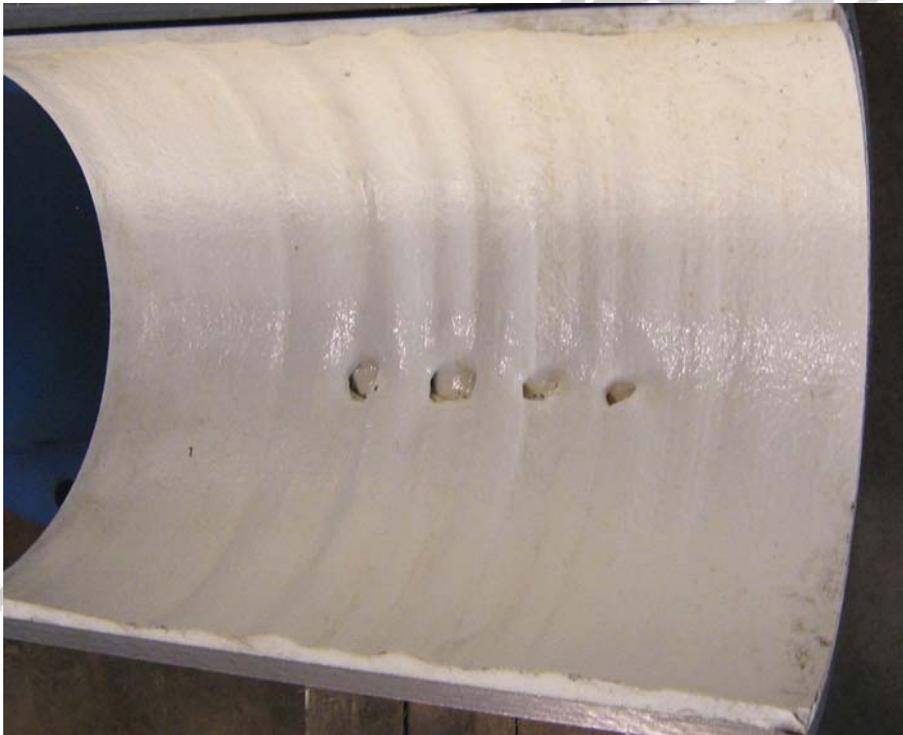
It was visible that the holes weren't completely filled with epoxy (Figure 14). Since the holes were not sealed, the leaks occurred where the water found a way through or around the epoxy. One test hole had a layer of epoxy so thin that changes in light could be seen through the epoxy, but it held the pressures and did not leak.

**Figure 14 Epoxy pushed into the holes.**

Greg Swartz, A & W Maintenance, warned about the problem of unfilled holes. He tried to remedy it by applying the epoxy from both ends of the pipe for better coverage. This was only possible on the coated pipe due to the welded end cap on the bare pipe. In larger diameter pipes the application would be applied with a hand held sprayer by someone inside the pipe. Any large holes or indentations would be visible and could be filled with epoxy during the application to avoid inclusions or voids in the lining. The Haysboro Feedermain is considered large enough for a hand held application.

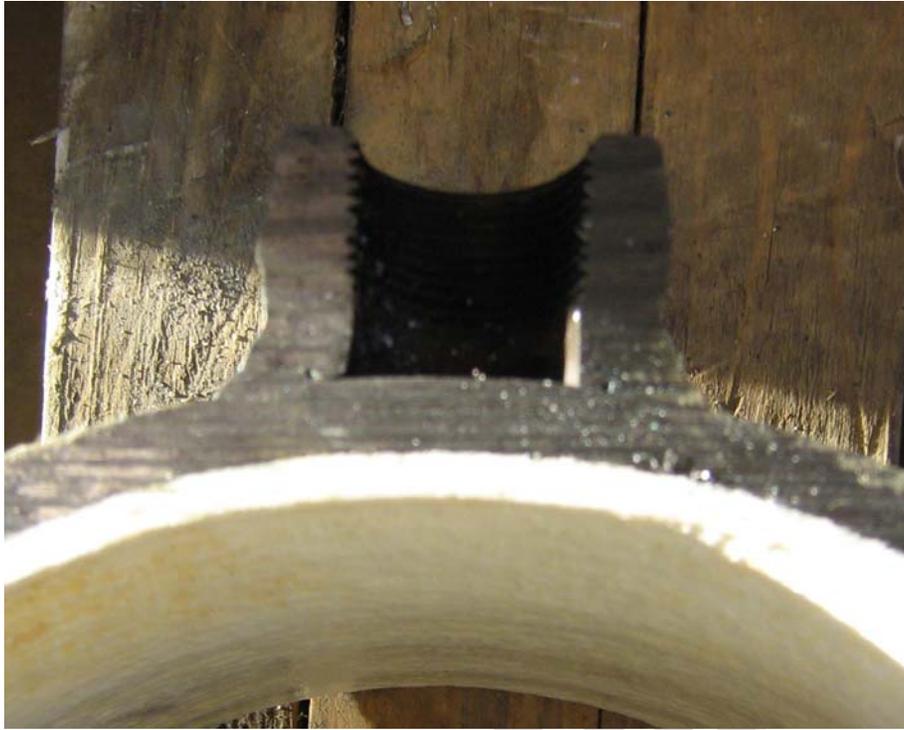
Figure 15 Weld.

The welding showed no effect on the epoxy (Figure 15). There was no discoloration or melting and the epoxy stayed fused to the wall of the pipe.

Since neither welding procedure showed an effect on the epoxy, any future repairs could be done externally without compromising the existing lining or water quality.
