WERF INFR1R12

## STRUCTURAL CAPABILITIES OF NO-DIG MANHOLE REHABILITATION

### Main Testing Summary of Results

#### Warren Test Results

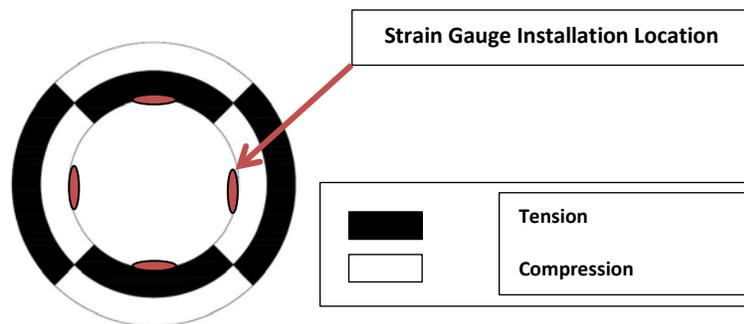
Figure 1- Stress/strain distribution along the pipe section loaded per ASTM C497 (D-Load) test and strain gauges installation location.

2. Strain gage installation by the project team – Upon completion of surface preparation, the Project Team installed strain gages to measure strains during loading at the locations shown in **Figure 1**.

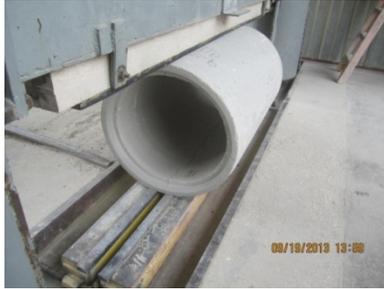
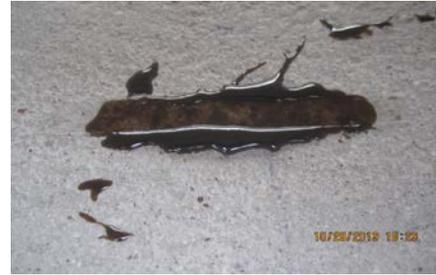
Figure 2- Three-Edge-Bearing Test Setup per ASTM C497 (a) and Strain Gauge Installation.

4. Testing by the Project Team – Three-Edge-Bearing Test per ASTM C497 was applied on control (unlined) and lined specimens. The standard ASTM procedure was slightly modified to measure strains during loading.

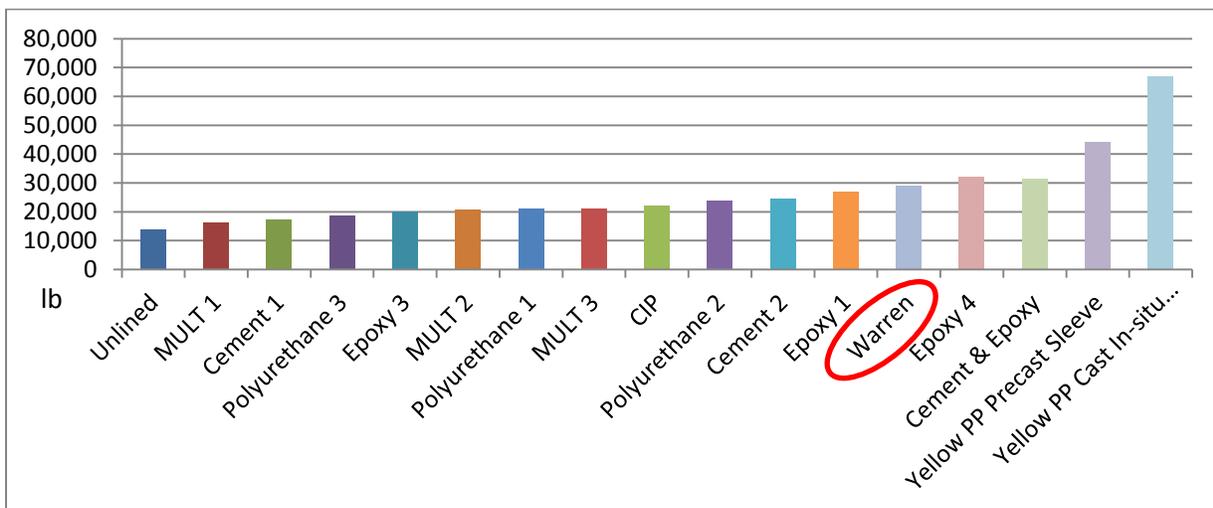
Figure 3- Final Test Results

The test results indicate that the epoxy lining material used by Warren Company has significantly increased the structural capabilities of the concrete samples. While the range of increase in failure loads was **45 to 133 percent**, in this case, the **concrete pipe's failure load was increased by 108 percent** as a result of being lined by epoxy material. Figure 3 shows the final test results. Also as a result of lining, the pipes became stiffer than the concrete pipes which resulted in lower values of deflection and strain in compression and tension zones comparing to the bare pipe.

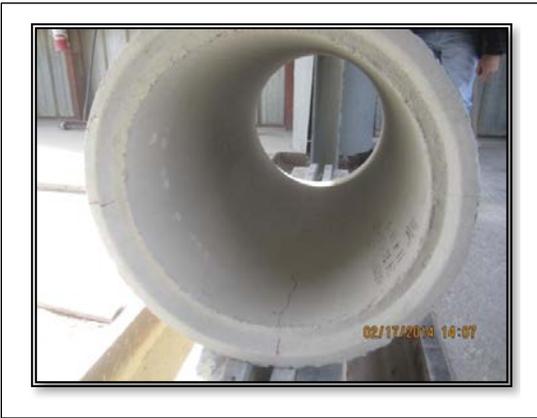
Figure 4- Unlined Concrete Pipe at Failure

<sup>1</sup> 1 Concrete pipe failed with longitudinal cracks on the outside at 3 and 9 o'clock and internal longitudinal cracks at 12 and 6 o'clock.

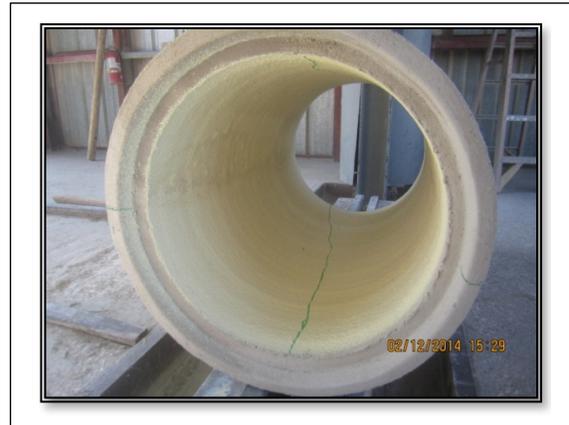
Figure 5- Lined Concrete Pipe at Failure

<sup>2</sup> Both Liner and Concrete pipe failed with longitudinal cracks on the outside at 3 and 9 o'clock and internal longitudinal cracks at 12 and 6 o'clock
