THE PASSAIC VALLEY SEWERAGE COMMISSIONERS

FINAL CLARIFIERS COATING/LINING EVALUATION PROJECT

POST IMMERSION SERVICE

FINAL TEST RESULTS

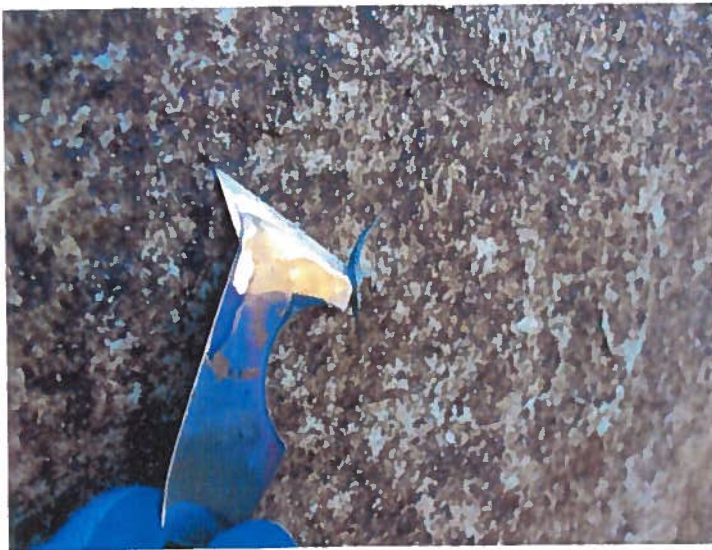
A visual inspection of Tnemec panel (P-6) - 217 resurfacing material and series 435 topcoat revealed substantial through-coating cracking that appeared to mirror similar cracking detected on the 217 resurfacing material on exposed uncoated perimeter locations (see photographs below):

The through-coating cracks ranged between ¼" to 1" respectively.

Due to the through-coating cracking detected on the Tnemec panel (P-6), CPI has no choice but to disqualify the test panel from the full scale clarifier rehabilitation project.

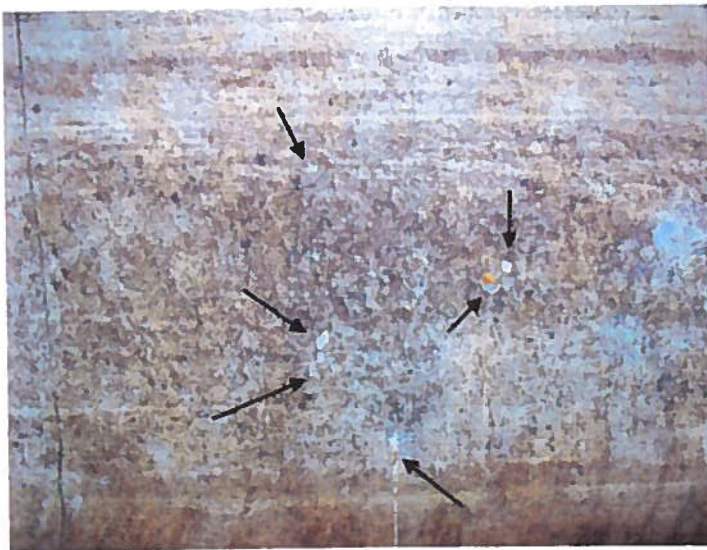
Through-coating cracks were chipped away from the surface using a five in one tool.

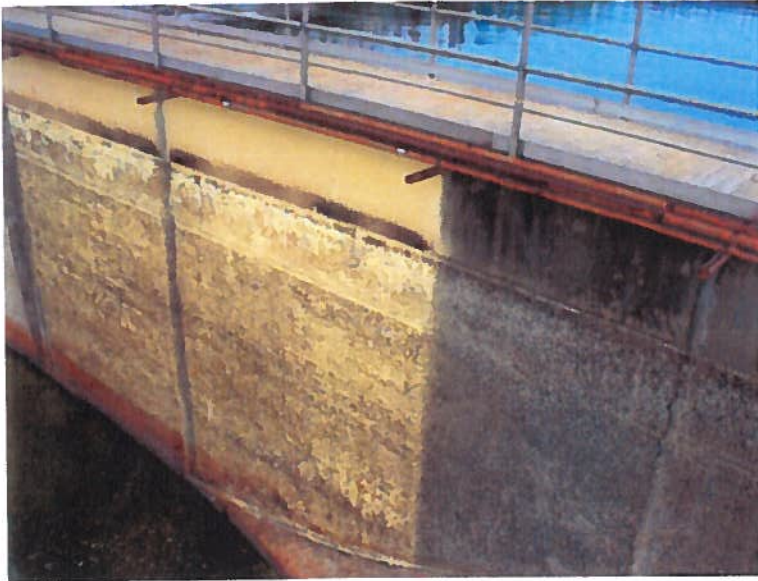
A visual inspection of Warren Environmental panel (P-8) S-301-14 without resurfacing material revealed no significant changes from the pre-immersion service inspection (see photographs below).

Overview of Warren Environmental S-301-14 material.

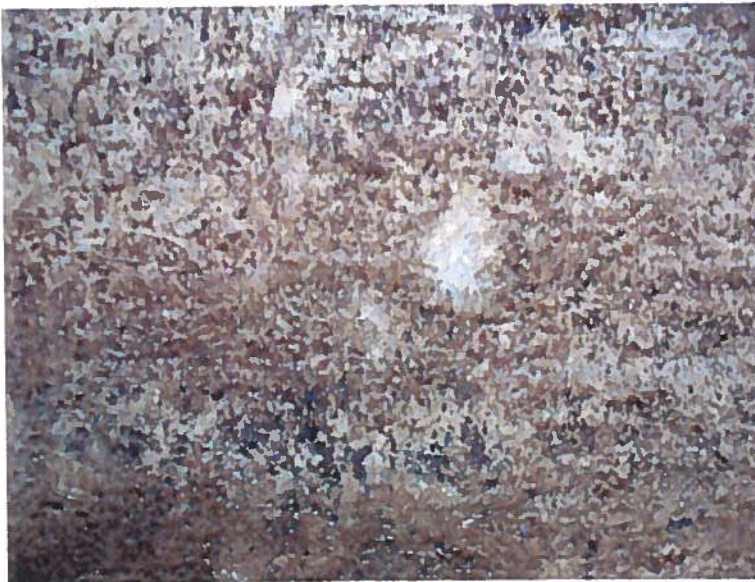
Detail of Warren Environmental S-301-14 material.

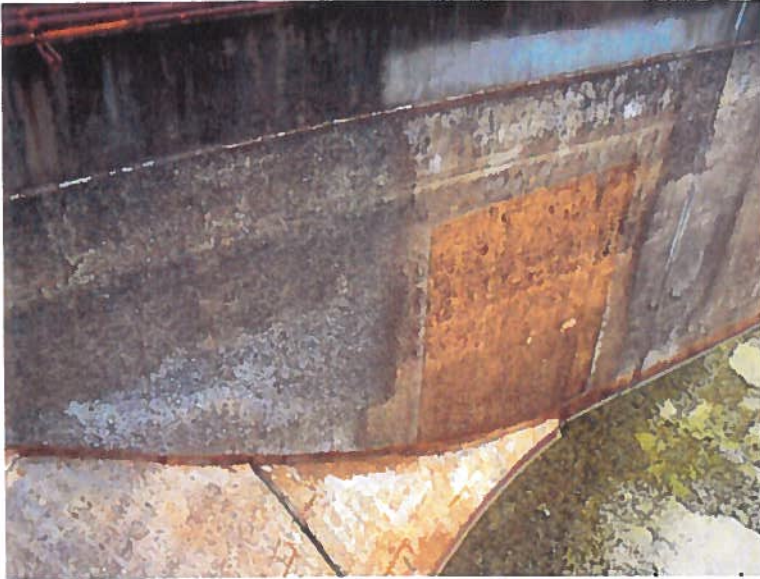
A visual inspection of Carboline 510 SG resurfacing material and fiber reinforced PolyBrid 705 topcoat revealed no significant changes from the pre-immersion service inspection (see photographs below).

Overview of Carboline panel (P-10) 510 SG/Fiber Reinforced PolyBrid 705.

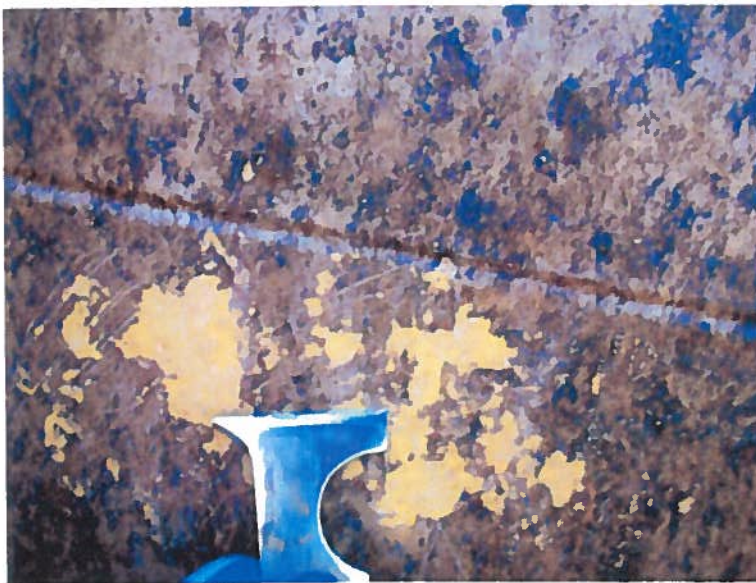
Detail of Carboline panel (P-10) 510 SG/Fiber Reinforced PolyBrid 705.

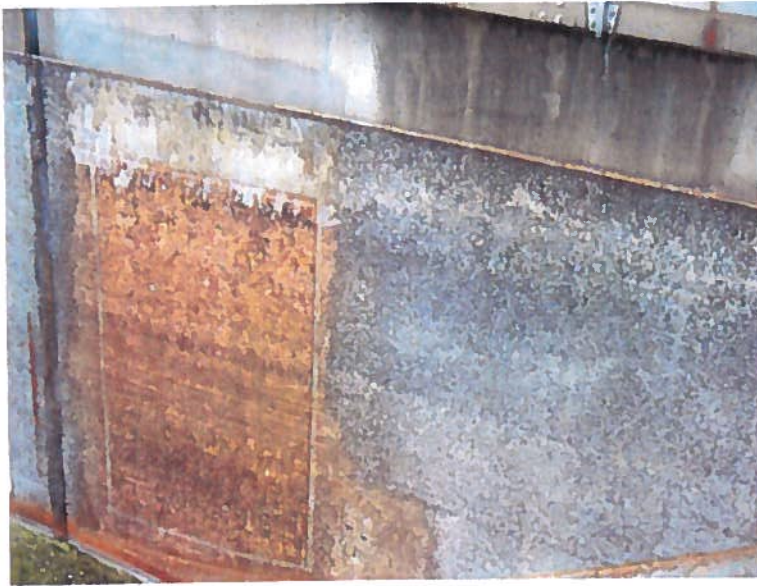
A visual inspection of Carboline 510 SG resurfacing material and PolyBrid 705 topcoat revealed no significant changes from the pre-immersion service inspection (see photographs below).

Overview of Carboline 510 SG resurfacing material and PolyBrid 705 panel (P-16).

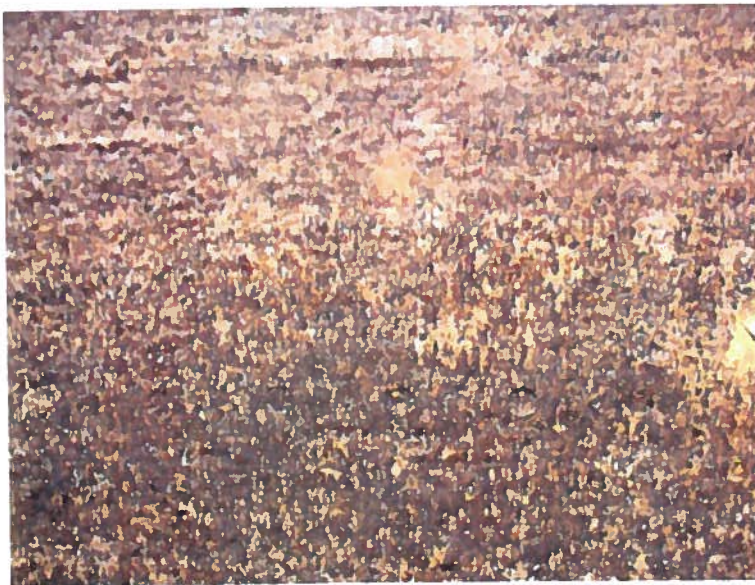
Detail of Carboline 510 SG resurfacing material and PolyBrid 705 panel (P-16).

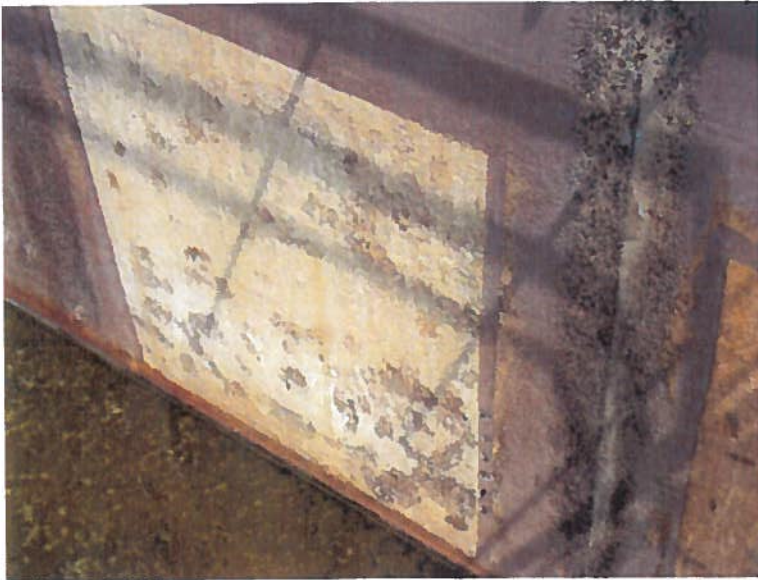
A visual inspection of the Saureisen panel (P-12) F-121 resurfacing material and 210 Glaze topcoat revealed no significant changes from the pre-immersion service inspection (see photographs below).

Overview of Saureisen panel (P-12) F-121 resurfacing material and 210 Glaze topcoat.
