# The Haysboro Water Feedermain - Product Test

S-301 Epoxy Spray System  
Warren Environmental Inc. and A & W Maintenance Inc.

THE CITY OF  
**CALGARY**  
WATER RESOURCES

February 11, 2009

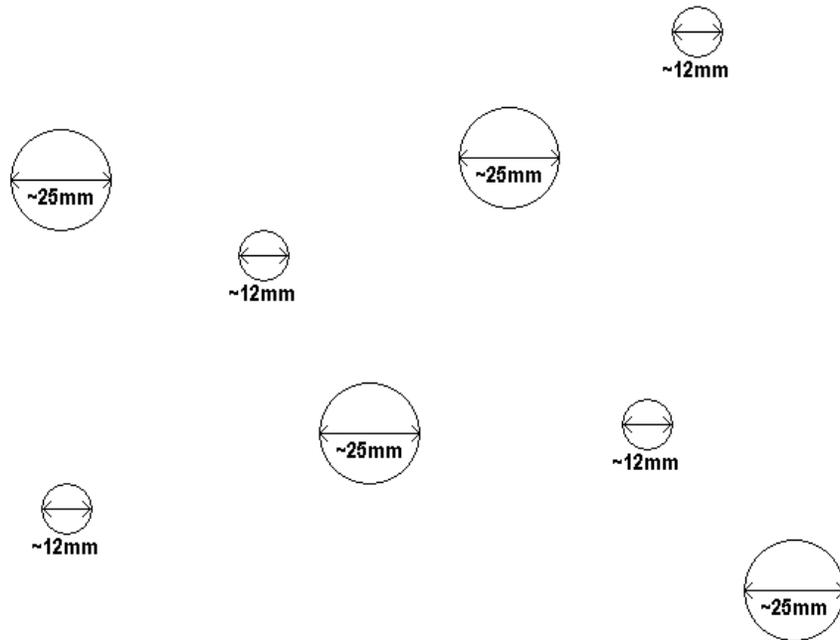
The bare metal pipe was drilled with two clusters of holes spaced approximately 12" (320 mm) apart. One cluster was comprised of four 25 mm (1") holes with edge distances of 10 mm (Figure 1) and the other was a group of eight random holes of 12 mm (1/2") to 25 mm (1") diameter (Figure 2).

**Figure 2** Approximate layout of the second group of holes on the bare metal pipe.

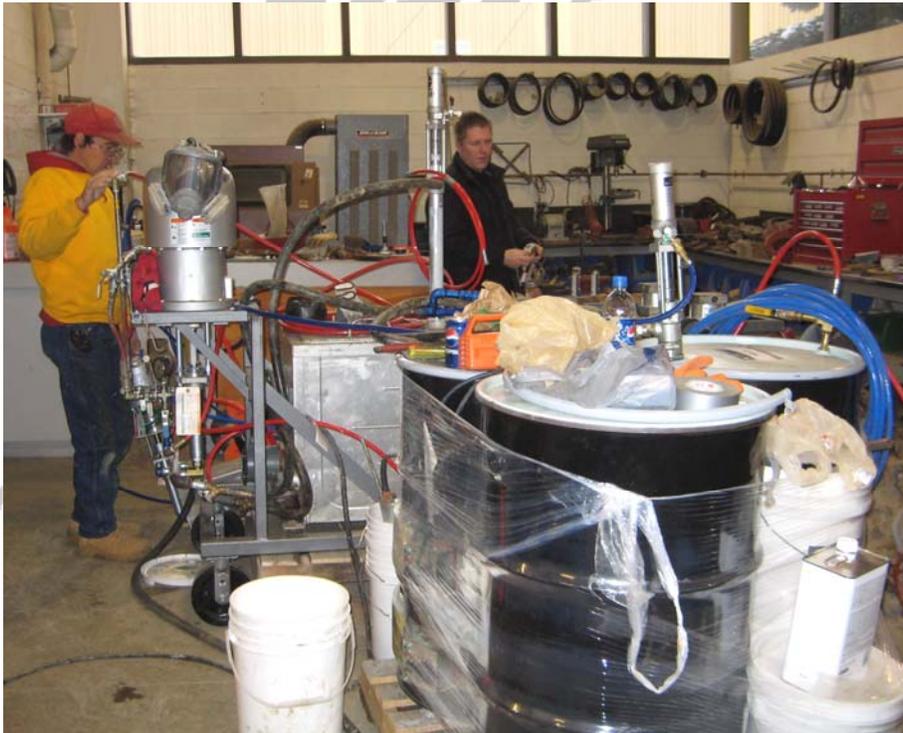
The application occurred during very cold weather so the epoxy had to be heated before it could be applied (Figure 5).

Figure 5 A & W Maintenance's machine set up.

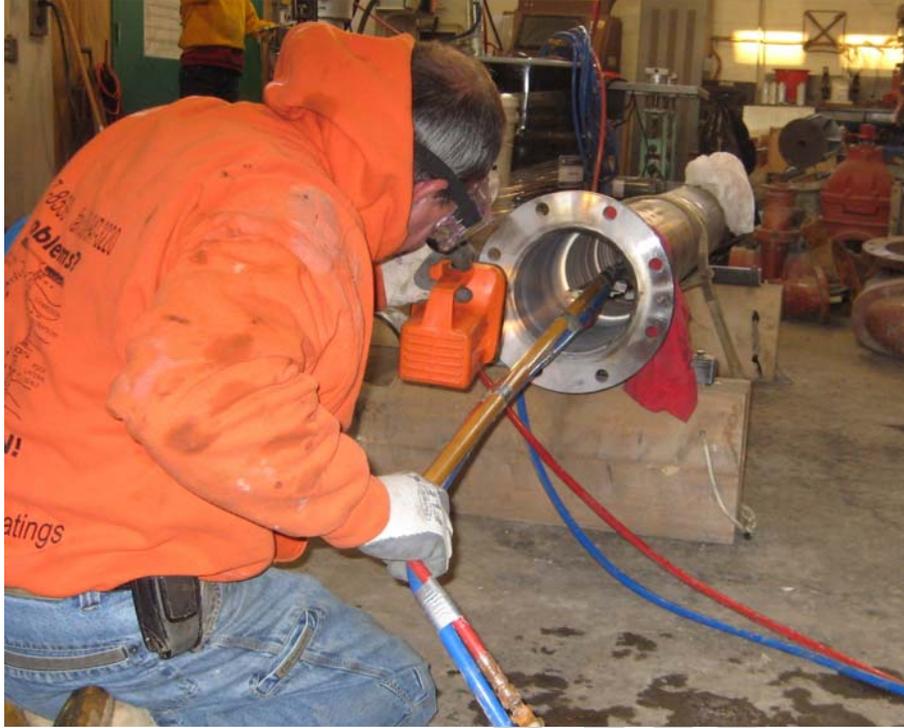
The product was applied using a spinner head pulled through the pipe by hand (Figure 6). There was nothing to control the speed of the application; therefore the thickness of the application varied slightly.

**Figure 6 Manual application of the epoxy.**

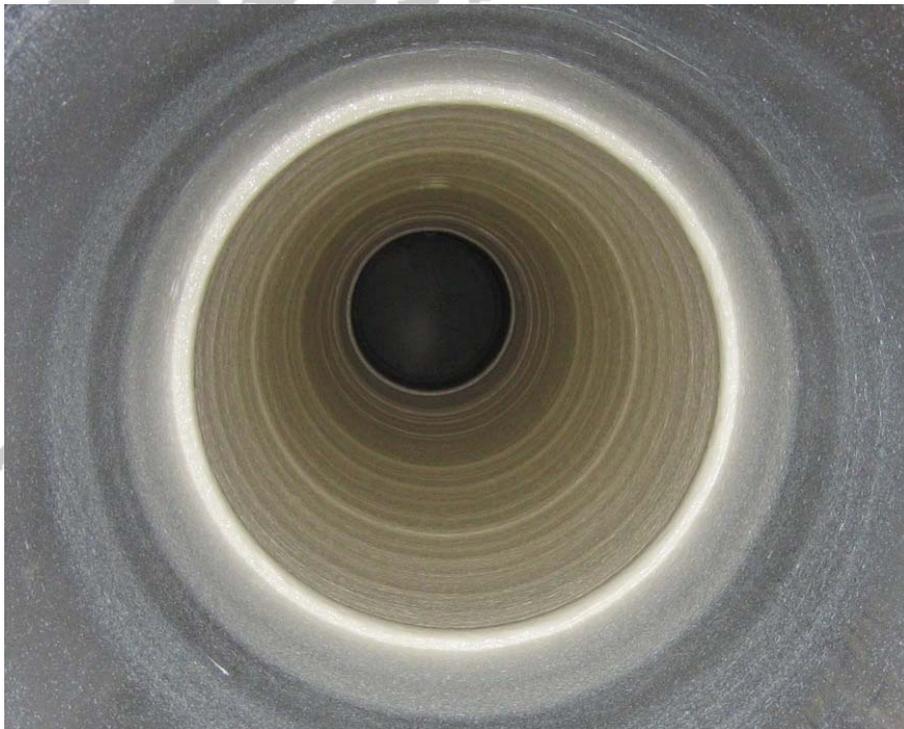
One coat was applied to each pipe and then allowed to cure for a few hours (Figure 7).

**Figure 7 First coat of epoxy inside the bare metal pipe.**

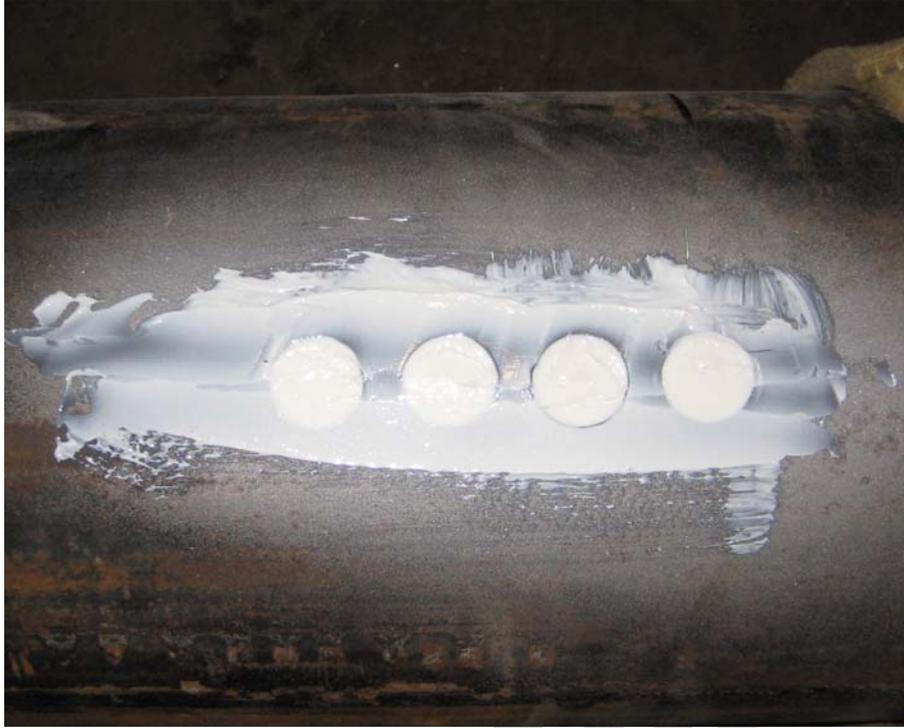
After a few hours, the duct tape was removed from the holes on the exterior. In an attempt to fill any voids, one thin layer was applied to the exterior of the holes followed by a second thicker layer (Figure 8, Figure 9, and Figure 10).

**Figure 8 First layer of epoxy, bare metal pipe.**

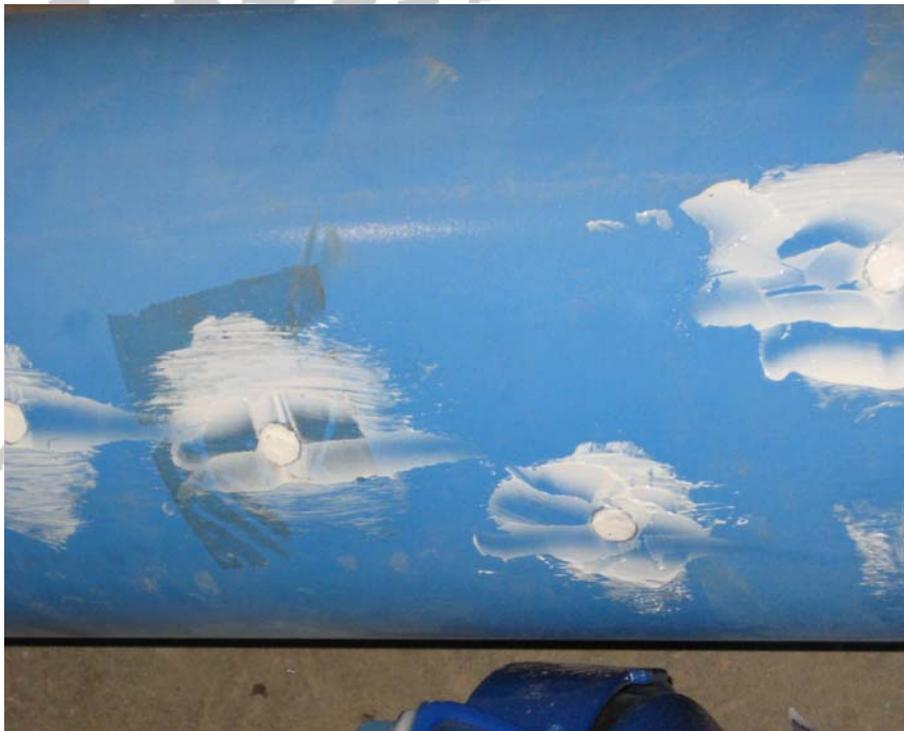
**Figure 9 First layer of epoxy, coated pipe.**

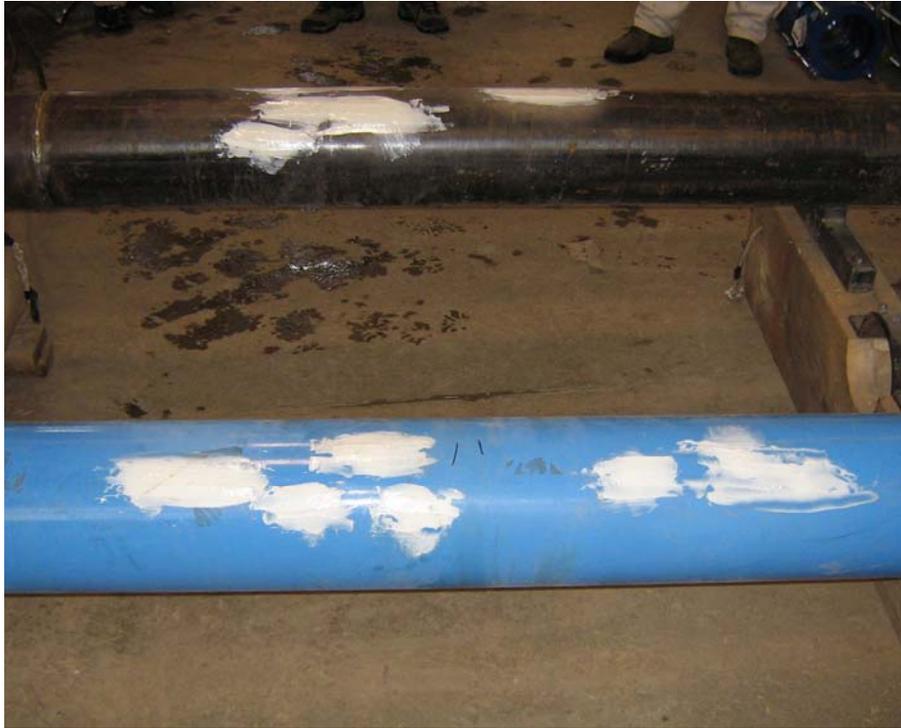
**Figure 10 Second layer of epoxy, both pipes.**
